NASA Technical Memorandum 79091

**EVALUATION OF A BRAYTON CYCLE RECUPERATOR
AFTER 21,000 HOURS OF GROUND TESTING**

**Thomas J. Moore
Lewis Research Center
Cleveland, Ohio**

February 1979

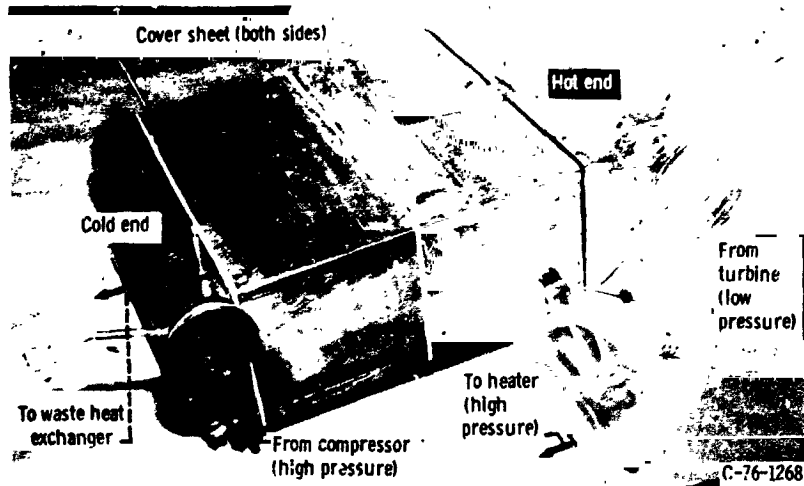
Two views of the recuperator assembly before sectioning are shown in figure 3. The recuperator was first saw cut through the core along the white lines. Next,

(a) Gas flow pattern, white lines indicate sectioning locations.

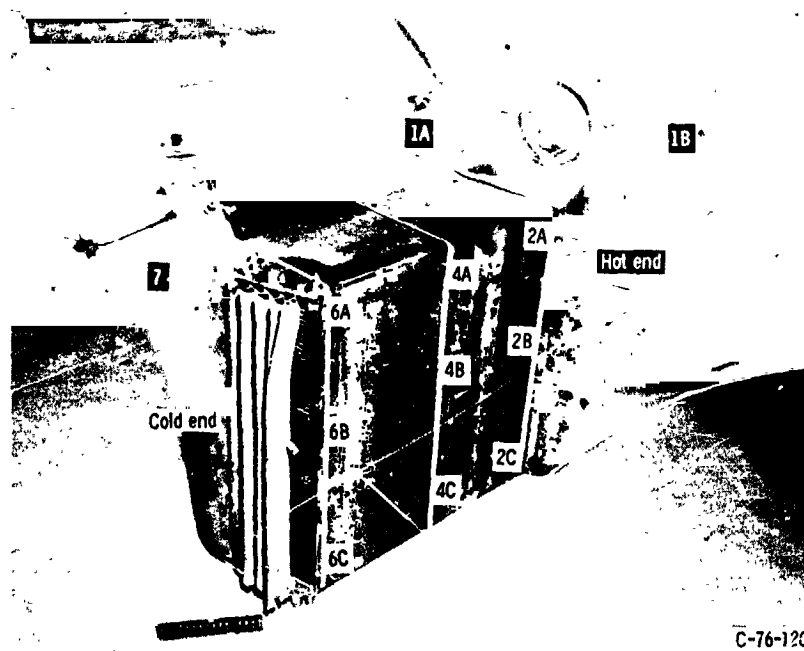
At the hot end (plug 2A in fig. 3(b)), the entire wall of the fin was oxidized, as shown in figure 6. No oxidation occurred in the plate because of the protective coating provided by the brazing filler metal. The oxidation, although similar in pattern, was more extensive in the 3.2-mm-high fins (which carry the compressor discharge gas) than in the 3.9-mm fins (which carry the turbine exhaust gas). Material scraped from the oxidized fins was magnetic. X-ray diffraction of the oxidized fins revealed that the oxidation product was primarily Fe_3O_4 . The microstructures of plugs 2B and 2C were similar to that of plug 2A, which was described above. Thus, at the hot end of the recuperator, oxidation of the fins was severe.

At midsection of the counterflow core (plugs 4A, 4B, 4C in fig. 3(b)), no oxidation problem was observed, and the braze joints were of fair to good quality. In the typical plate-and-fin brazement microstructures (fig. 7) some voids and porosity are evident in the braze metal.

At the cold end of the recuperator, the brazed joints were of good quality with no evidence of deterioration. The microstructure shown in figure 8 for plug 6B also is typical for the other cold end locations (plugs 6A and 6C, fig. 3(b)).

(b) Locations of plug removal from the core and sections taken through weld joints in the ducting.

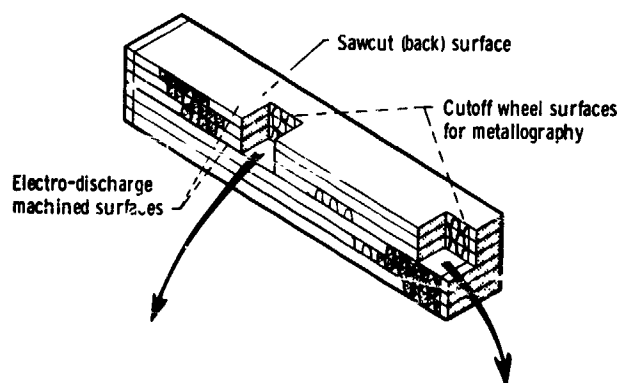
Section 4B4

(a) Central portion of plug showing plate/fin construction.

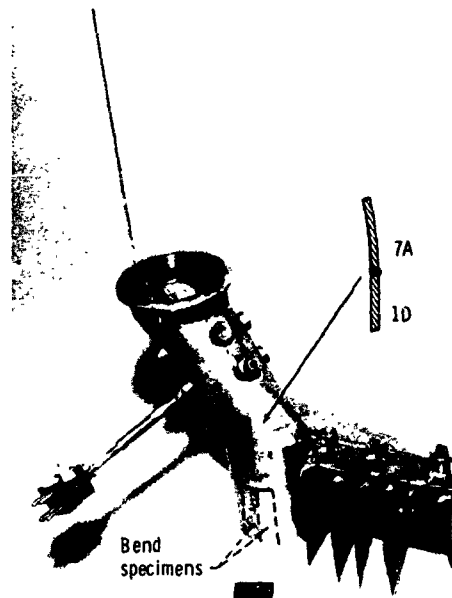
Figure 14. - Cutout and bond specimen locations in type 347 stainless steel ducting at cold end of the recuperator.

At the cold end of the recuperator (figs. 3 and 14) the weld in the type 347 stainless steel ducting was sound. There was no evidence of oxidation at the inside surfaces in this area (fig. 15).

Bend test specimens were obtained near the location from which the metallographic specimen was taken (fig. 14). Duplicate specimens, 1.27 by 14 by 54 mm with the inner ducting surface in tension, passed a 60° guided bend test over a 2t radius at room temperature. The specimens were then bent 180° in a vise with no evidence of cracking, thereby demonstrating that the inherent good ductility was retained.

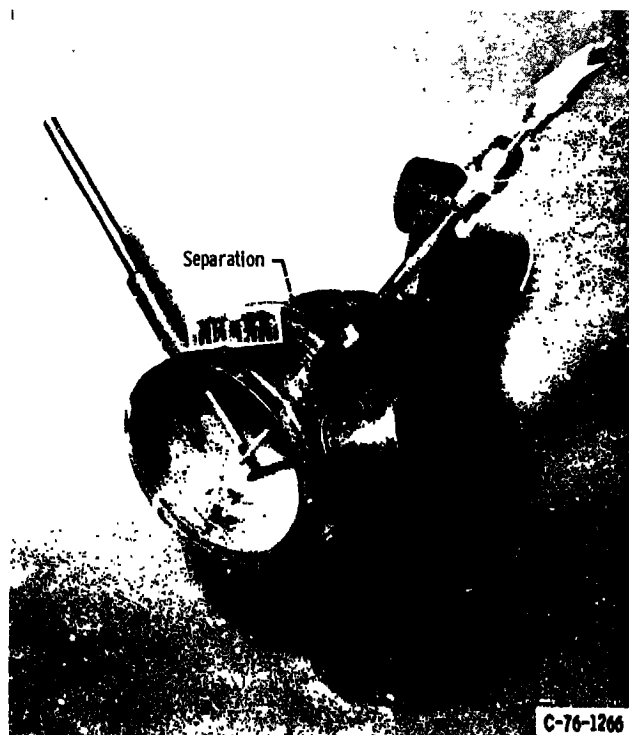
Figure 16. - hastelloy X elbow / type 347 stainless steel double-wall bellows assembly.

A portion of the Hastelloy X ducting, which carried the working fluid from the turbine exhaust to the recuperator is shown in figure 16. The double-wall bellows was made of type 347 stainless steel. During dismantling of the recuperator, the Hastelloy X material exhibited brittleness in that it cracked at the base of a knob at a fillet weld and separated from the ducting. By using EDM, section 1C in figure 17 was obtained without breaking off the small part of the knob that remained attached to the ducting. Figure 18(a) illustrates the incipient toe crack in the ducting immediately adjacent to the fillet weld. The typical base-metal microstructure is shown at higher magnification in figure 18(b).
